How to change Inlet Guide Vanes . . .

. . . WITH THE ROTOR IN PLACE

CHARLES POND AND
DAVID LUCIER

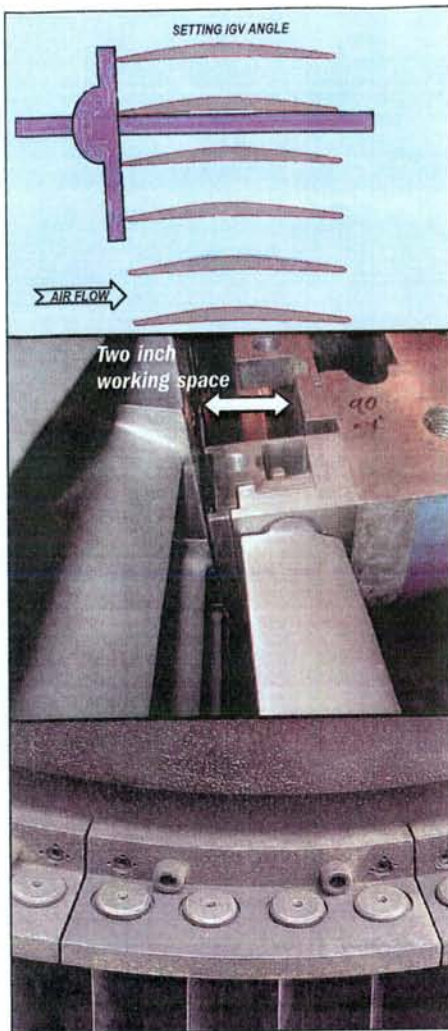
Older IGVs were susceptible to cracking where the airfoil met the shaft. This was a serious concern (TILs 511, 515, 522, 532). The crack can lead to a catastrophic IGV failure. Failures occurred at about 25,000-30,000 hours of operation. Crack inspection needs to be performed at 4,000-hour intervals. New-style IGVs incorporate a small fillet (Figure 6)

to prevent crack formation.
