TURBINE TIPS

November 2004

Subject: Ward-Leonard Replacement Relays

Applies to: GE gas turbine models MS5001K, L & LA and MS3002F

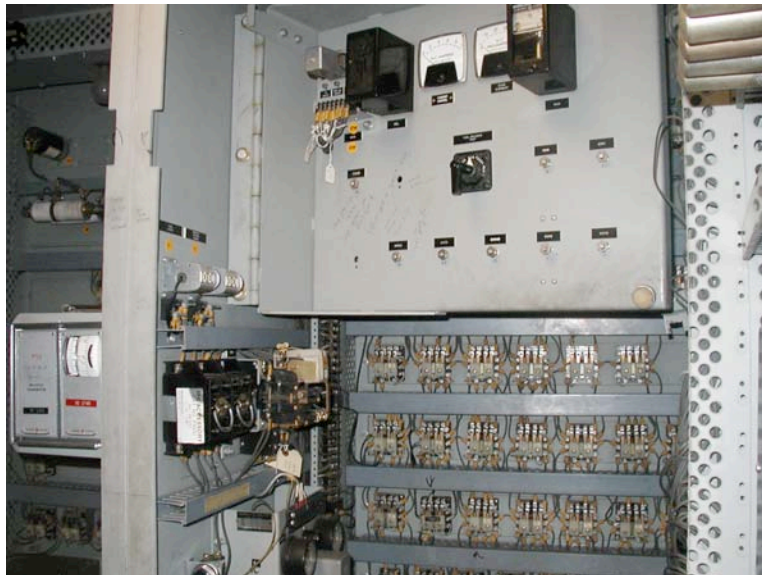
Fig. 1: GE control panel with Ward-Leonard relays on rear wall

The *W-L* relays were open to the atmosphere and subject to corrosion and dirt. Also, arcing problems often result in carbon discharge on the relay contacts. Now there are reliable relay replacements that fit in the same “footprint” and wiring configurations as the original *W-L* relays. The *PAL* relays are mounted in the same location with the same wiring as shown in Fig 2 below.

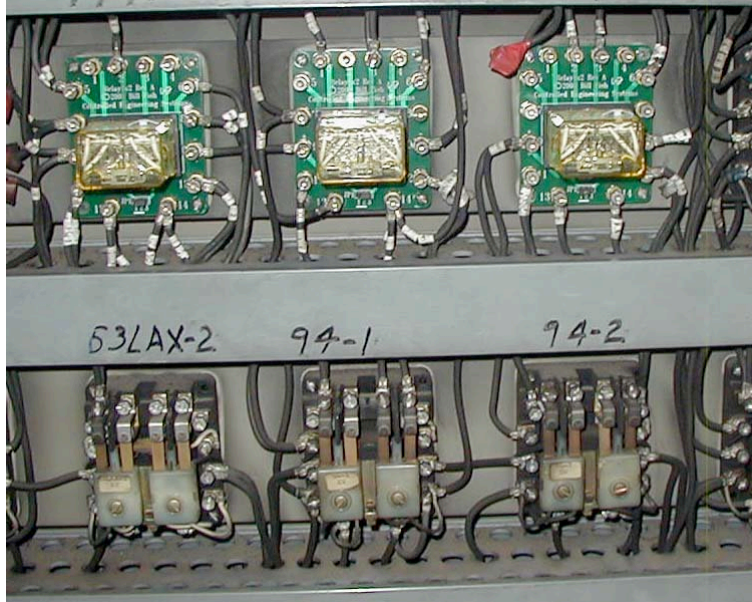
Fig. 2: PAL relays replace Ward-Leonard relays in the same footprint and wiring pattern

The W-L relays in Fig. 2 above distinctly show carbon build up on the relay arms and contacts. The original wiring is shown with wire numbers with the new *PAL* relays.

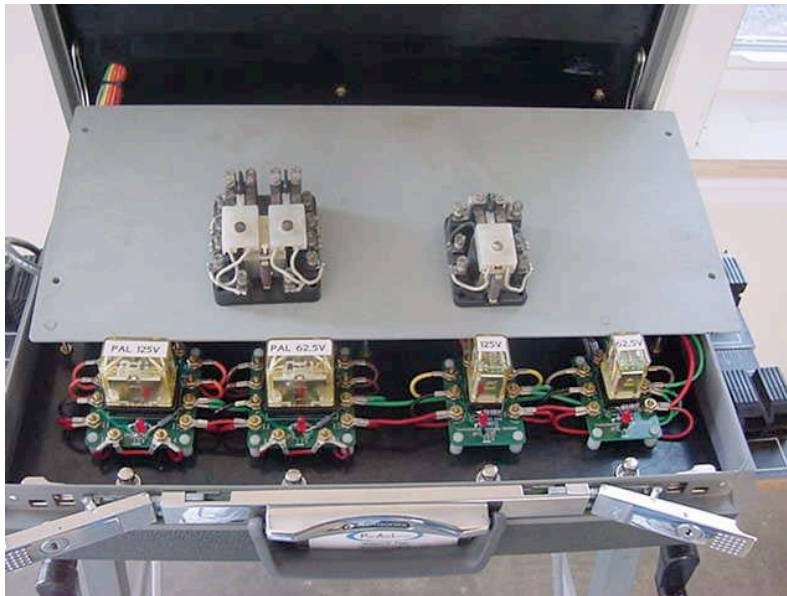
Fig. 2: Ward-Leonard relays shown with PAL relays in test kit

The *PAL* relay replacements have two components: the plug in relays and the mounting blocks. Both the relay and the block have **LED** lights. When power is available to the block (indicating that the relay **should** be energized), the light on the block will be lighted. If the relay is functioning properly, it will “pick up” and its light will also turn on. Thus, the lights should always match. In the test rig shown in Fig. 3 below, the advantage 2-light setup is obvious. See the lower half of the photo as the engineer energizes the relay by pressing the test pushbutton. Both lights turn on.

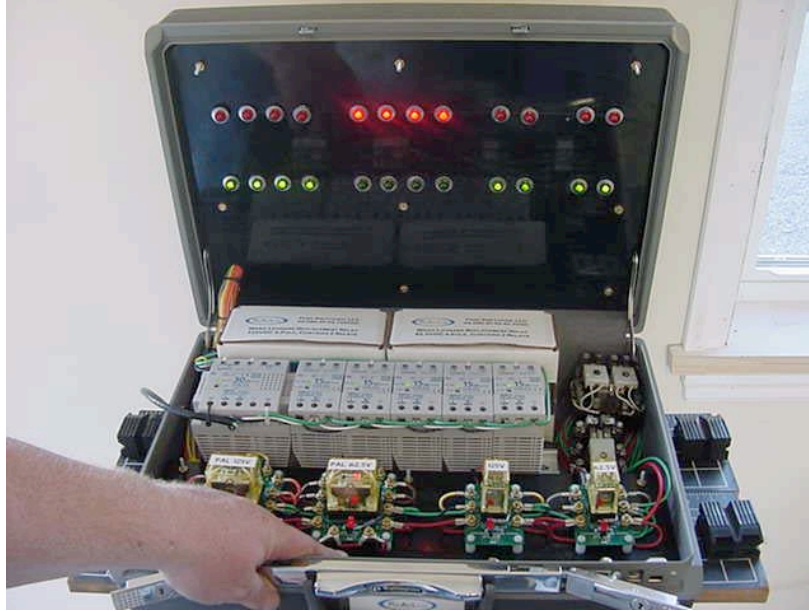
Fig. 2: 4-pole PAL relay being tested showing contact closures with red LED

The test rig above also shows four red lights lighted for the relay being tested below. This type of relay has four normally-closed (NC) and four normally-open (NO) contacts. The red lights indicate that all the NO contacts have **closed** with the energization of the relay. Test rigs for the relays are also available from ***Pond and Lucier, LLC***.
