TURBINE TIPS

October 2004

Subject: NY Airbrake Fuel Pump Failures

Applies to: GE Gas Turbine MS5001N gas turbines (circa 1970-71)

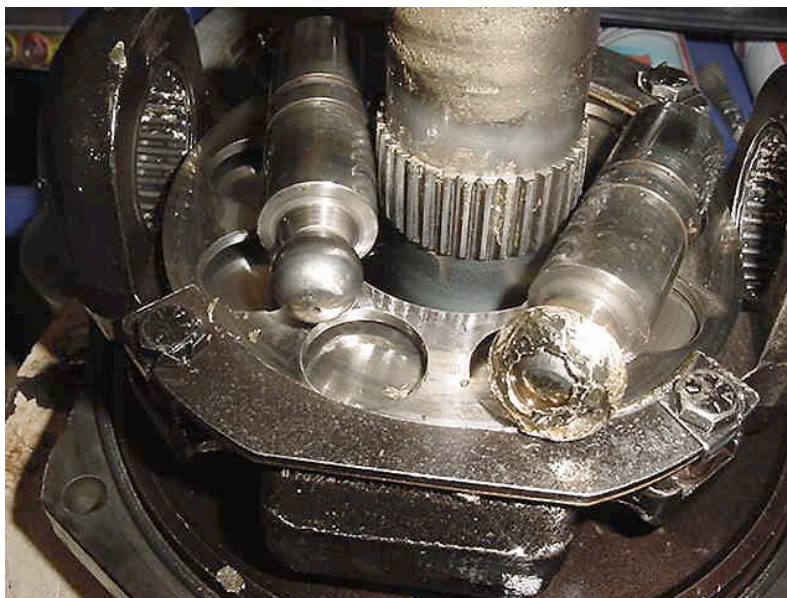
Gas turbine owners have noticed problems with these pumps after as few as 1000 operating hours. An owner in the Bahamas noticed that there was an increase in lube oil consumption (from the turbine system) at approximately one barrel per day (**that's 55 gallons per day!**) due to internal seal failures

of the *NY Airbrake* pump. **Note:** This pump is not supposed to be ingesting any oil from the turbine's lube oil system.

Fig. 2: Failed NY Airbrake Axial-piston Fuel Pump

The failed pump shown herein was serviced and saved, even though the photos suggest a catastrophic loss. *Pond And Lucier, LLC* was able to purchase the replacement parts, clean the remainder of components and reassemble it in approximately two weeks.

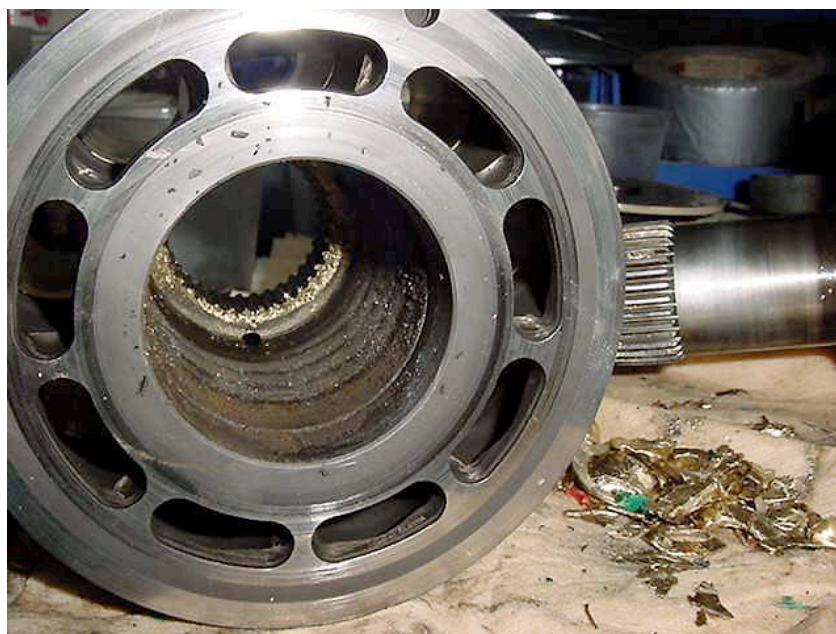
Fig. 3: Failed NY Airbrake Fuel Pump with copper debris

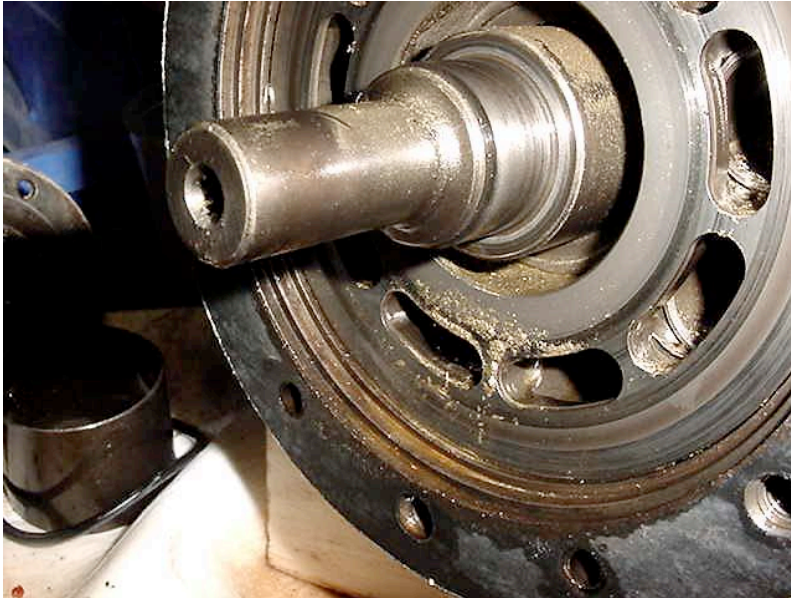
Fig. 4: Failed NY Airbrake Fuel Pump with copper debris
