TURBINE TIPS

September 2004

Fairchild Millivolt Flame Detectors

Applies to: General Electric MS5001L & LA gas turbines, circa 1967 - 1969.

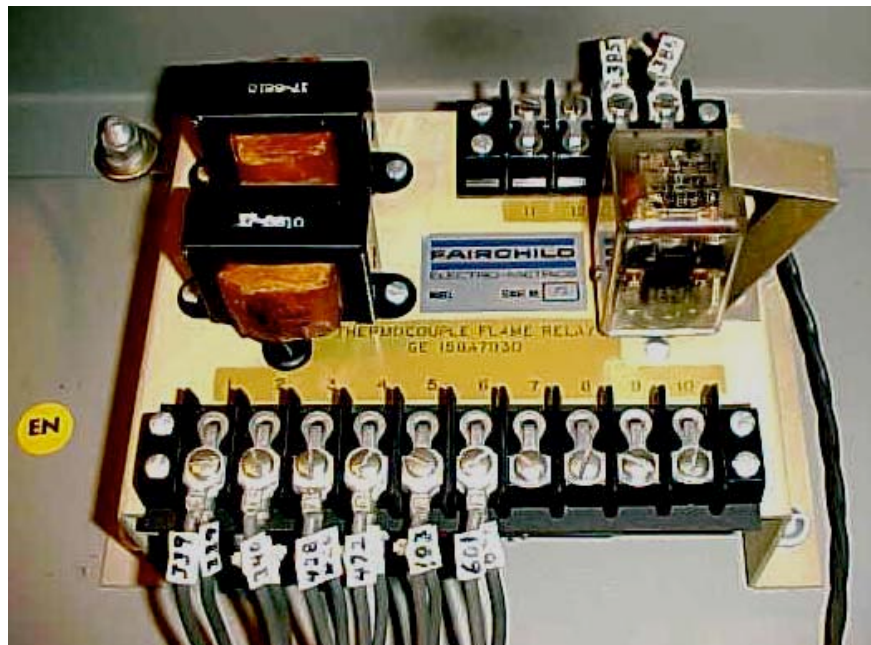
GE gas turbines manufactured in the late 1960s utilized a thermocouple flame relay manufactured by *Fairchild Electro-metrics*. This was not, in reality, a flame detector. It was an exhaust heat detector that “simulated” flame. See Figure 1 below. The device took the averaged exhaust temperature (TX) to determine if flame must exist in the combustors.

Fig. 1: Panel-mounted Fairchild Millivolt Flame Detector (GE drawing 158A7930)

The *Fairchild* thermocouple flame relay should be calibrated to acknowledge that “*flame*” is present when the millivolt signal equivalent to 500 °F (22.6 DC millivolts) is sensed. Loss of flame, on the other hand, should trip the gas turbine if the temperature drops below 300 °F after the turbine reaches operating speed. This presents a problem for this type of flame detector, because the “drop out” of relay 20FD is about 475 °F. This problem is noticed when the turbine reaches operating speed and fuel is cut back as it goes on governor control. At full speed, no load (*FSNL*, 5100 rpm), sometimes the exhaust temperature drops to about 450 °F, which would ordinarily cause a “*flameout*.”

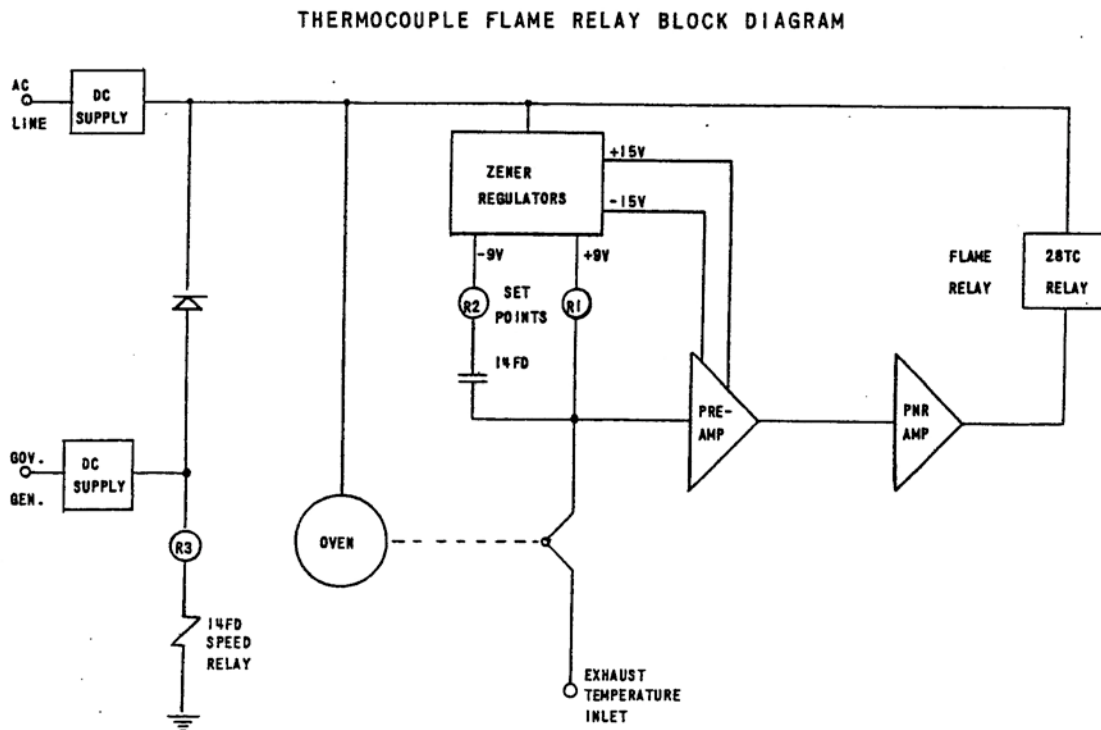
To prevent flameouts, *Fairchild* installed a speed relay (called 14FD) behind the panel. This relay would sense the turbine speed from the turbine’s tachometer generator. An adjustment resistor is used to “*bias downward*” the dropout point of relay 28TC. In short, the relay was adjusted to pick up at 500 °F but drop out at 300 °F, well below the temperature expected at *FSNL*. Thus, this biasing would obviate a tripout when the turbine reached operating speed.

Fig. 2: Fairchild Thermocouple Relay Block Diagram

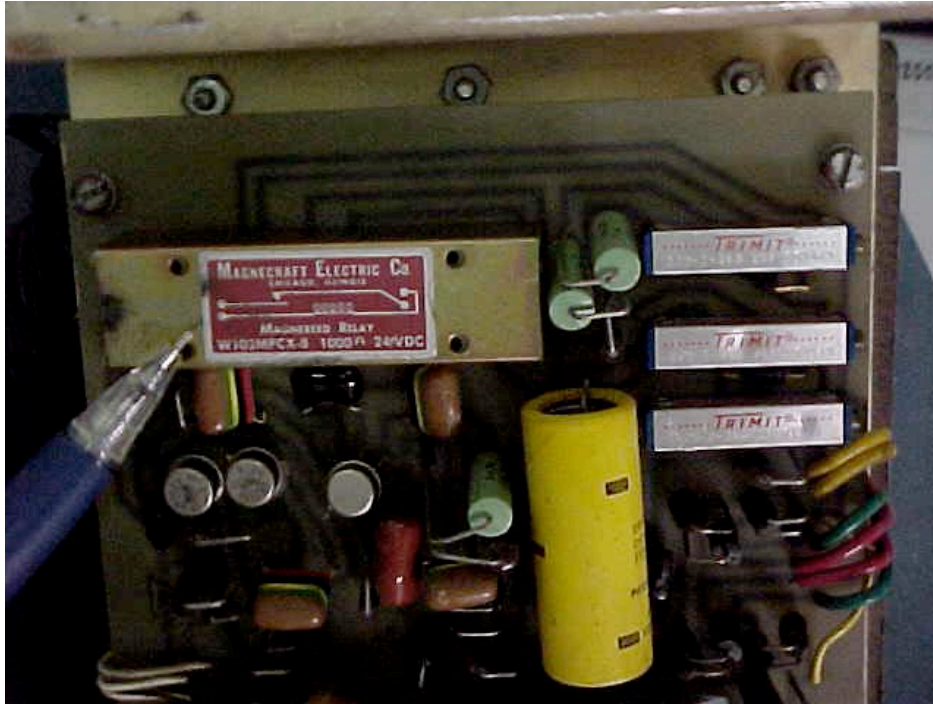
If your turbine is tripping out at *FSNL*, it may be that **14FD** has failed to energize (NOT picked up) when the turbine reaches approximately 3500 rpm. This is approximately 105 AC volts on the fuel regulator’s tachometer generator. It is also possible that the coil on relay **14FD** has failed. Relay failure is difficult to detect because it is located behind the panel. See the chart below

Fig. 3: Pencil pointing to 14FD relay underneath flame detector. Three Adjusting resistors on right.

The Variac allows for speed relay **14FD** located on the Flame Detector panel to introduce a "biasing" circuit for the drop out of relay **28TC**. This is done because the exhaust temperature at full speed/no load on the gas turbine is about 450 deg. F. By coincidence, this temperature is also the approximate "unbiased" normal drop-out level of **28TC**. Thus, by introducing the circuit associated with **14FD**, the drop-out point of **28TC** is effectively decreased after the turbine reaches approximately 3500 rpm (105 VAC out of the tachometer generator).
