Replacement of damaged lower IGVs with rotor in place saves IMPA a million

Scott Berry, plant manager for Indiana Municipal Power Agency's Anderson and Richmond peaking plants, confirmed this. He told attendees at the Frame 6 Users Group annual meeting last June that IMPA saved about \$1-million on IGV overhauls for four Frame 6Bs (two at each plant) by keeping the rotors in the machines while the work was done. Berry is a member of the group's steering committee.

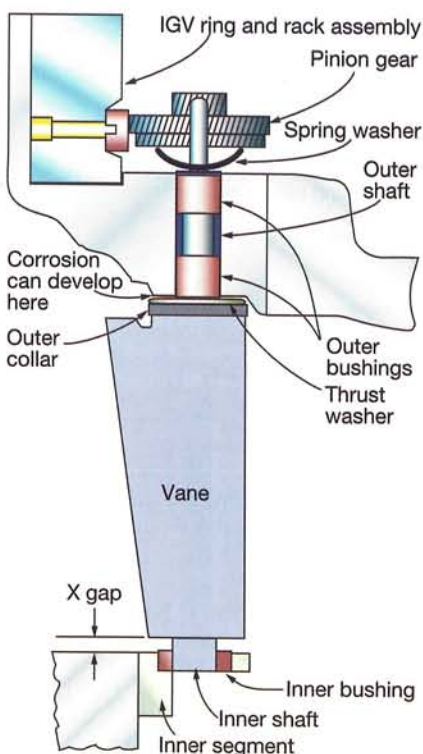
2006 "peaking season" and while calibrating IGVs found that at least some vanes were not moving freely. Close inspection revealed that several vanes were hanging up at the top (inner ring) because the so-called "X gap" in Fig 1 had closed up; it

1. Inlet guide vane simplified sketch shows corrosion is most likely where the thrust washer is located

should be about 9 mils. This condition was attributed to deterioration of the metal thrust washers installed in the IGVs when then engines were built 15 years ago. Specifically, rust pushed up the vane into the inner ring impairing its motion. The thrust washer is retained in a cup that can collect water from washing and fogging sprays thereby enabling the corrosion process.

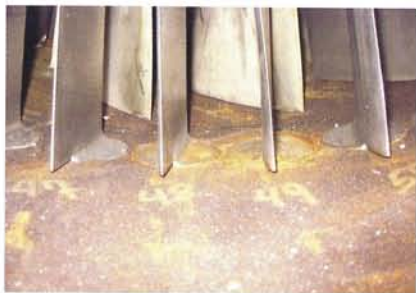
2. Vanes 48 and 49 are in the 6 o'clock position and the ones most likely to have corroded thrust washers

Vanes 48 and 49 in each machine were replaced along with a few others (Fig 2) because of twisting damage sustained as the ring and rack assembly tried to turn blades wedged into the inner ring. Note that vanes 48 and 49 are in the 6 o'clock position and the ones most susceptible to water retention. Berry mentioned that he had difficulty finding a supplier willing to provide less than a full row of vanes. The old style metal thrust washers (Fig 3) were replaced by nonmetallic washers (Fig 4) on all vanes.

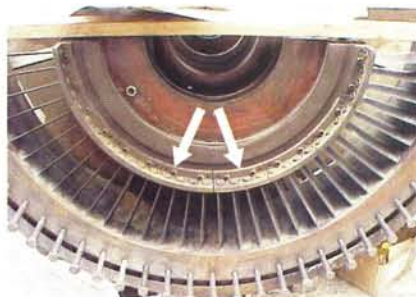
To better illustrate the challenges of the job, Pond presented photos of the lower bellmouth from another project where the rotor had been removed (Fig 5). Each segment (arrow in photo) retains four IGVs. The close-up (Fig 6) shows there are two dowels, each staked in four places during assembly, and two screws holding a segment in place. Note that the dowels have a center threaded hole.

5. Inner ring segments are in evidence on lower half of bellmouth from unit where the shaft was removed

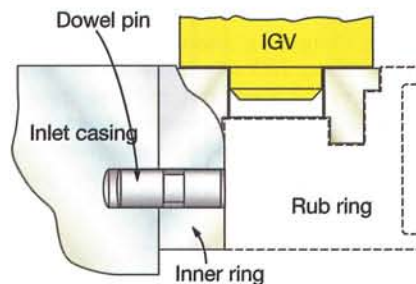
Caution: Dowel pins must be pulled straight out to prevent the jacking bolt from breaking off. Should a bolt break, the rotor must be removed—a very costly consequence. Fig 7 shows the relative position of key parts.

7. IGV inner ring assembly illustrates position of components

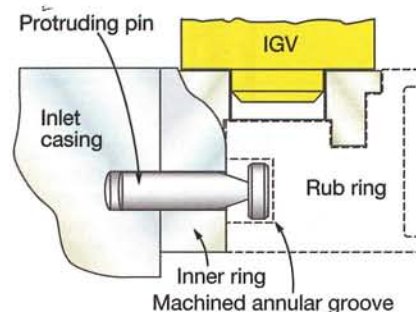
9. Groove is machined into rub ring to accommodate the T pins

Reassembly of the IGVs may be different for the top half of the bellmouth than for the bottom half. To facilitate IGV removal in the future with rotor in place, so-called T-pin dowels are used in the bottom half of the bellmouth in place of the headless dowels originally installed. T pins look somewhat like golf tees (Fig 8) and are relatively easy to remove with a pry-bar type tool. However, to accommodate the protruding pins, a groove must be machined out of the lower-half rub ring (Figs 9, 10).

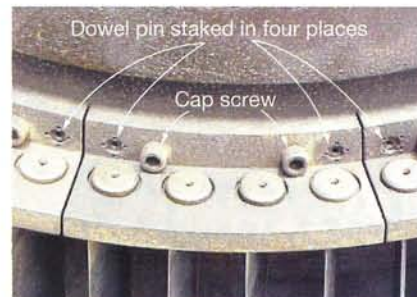
6. Each ring segment is retained by two staked dowels and two cap screws

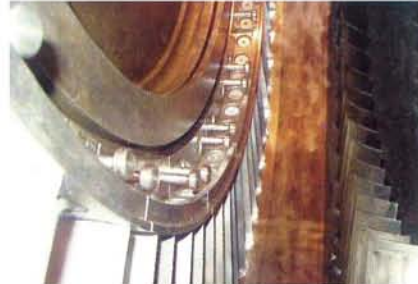
8. T pins replace original dowels in the lower half of the bellmouth to facilitate access to guide vanes in future outages

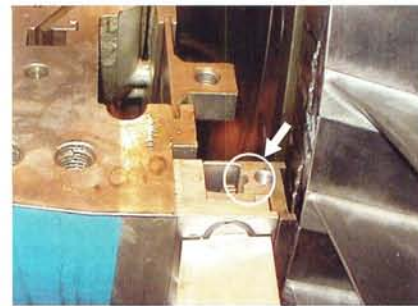
10. Rub-ring groove runs around the lower half of the bellmouth from horizontal joint to horizontal joint

replaced with T pins, both halves of the rub ring must be machined to allow the space.
