# TURBINE TIPS

**February 2004**

**Subject: MAINTENANCE FACTOR FOR EMERGENCY FAST START OF GE HEAVY DUTY GAS TURBINE**

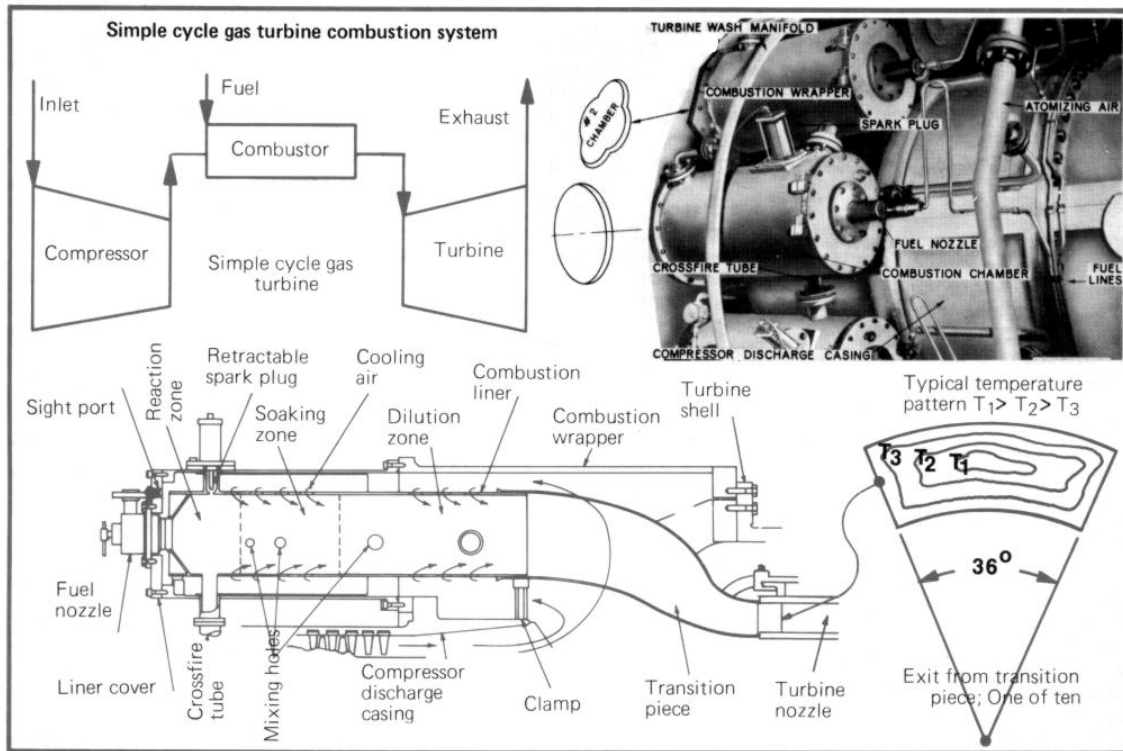
- The combustion system must be easy lighting. The GE system is intended to have a "Lean" combustion regime. Using a firing speed of  $<$ 15% pushes the combustor into a "Rich" regime due to too much fuel for the available air flow, which is contrary to the GE design intent. The "Delta-P" across the combustion liners is by design on the order of magnitude of 1.5 to 2.0 psig; if the Air-to-Fuel mixture is not at design point, then combustion hardware damage can occur prematurely.

- A stable flame pattern must be readily established in the spark plug chambers and then the flame must propagate quickly & reliably through the cross-fire tubes to the other chambers. Additionally, the mixing & dilution of the flame zone air along the length of the combustor must be such that a stable pattern factor is developed at the exit of the combustion transition pieces. If the isotherms of the pattern factor are not evenly distributed, then extreme overheating of the Stage 1 Nozzle Partitions occurs at the junction with the Side Wall of the nozzle. This is the most highly stressed portion of the nozzle & significant, premature cracking will occur. The Stage One Buckets will, of course, also be exposed to these off-design conditions.

- During the firing and acceleration mode of the start-up, temperature control is not implemented in the same manner as it is when the unit is at full speed and when it is loaded. Accordingly, temperature excursions can rapidly occur in the combustion and hot gas path sections as described above.
3. Another consideration when firing at <15% speed is that any off design conditions in the compressor, such as fouling, corrosion, erosion or Foreign Object Damage, could lead to compressor surge. Such an event at off design combustion conditions could well lead to an unstable flame pattern progressing upstream with potentially disastrous results.

4. If a GE Heavy Duty Gas Turbine is so equipped with the Emergency Fast Start feature, it should only be utilized to support a bona fide emergency situation. Customers should carefully consider the long-term maintenance impact of using the Emergency Fast Start feature.
