May 2006

Subject: What does “complete sequence” mean?
Applies to: General Electric Gas Turbines
Examples used herein: Speedtronic™ Mark I and II)

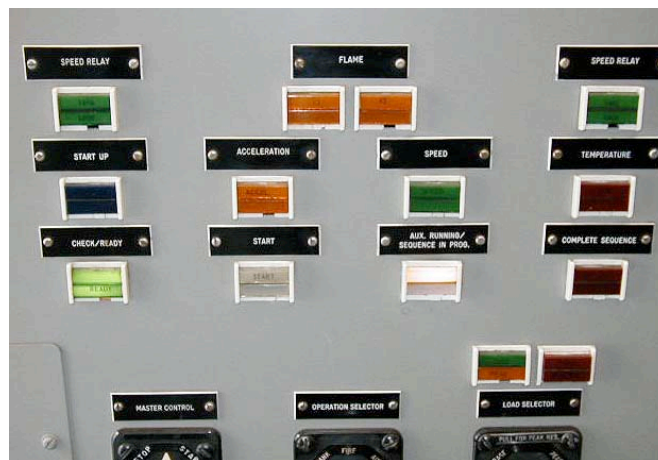
General Electric gas turbines installed in the 1960s - 1980s had a panel light to indicate **Complete Sequence**. This term means that the turbine has reached operating speed and that all of the motor-driven auxiliaries that *should shut down, have indeed shut down*. It should be remembered that the gas turbines start with motor-driven auxiliary devices. For example: **88QE**, the DC motor-driven lube oil pump is used for black-start turbines. Another example would be for a turbine starting on liquid fuel, **88CA**, the AC motor-driven atomizing air compressor is required. Once the turbine reaches operating speed, these motors should stop and **Complete Sequence** should illuminate. See Fig. 1 in the lower right of the picture.

Fig. 1: Complete Sequence lights on Mark I Speedtronic Panel

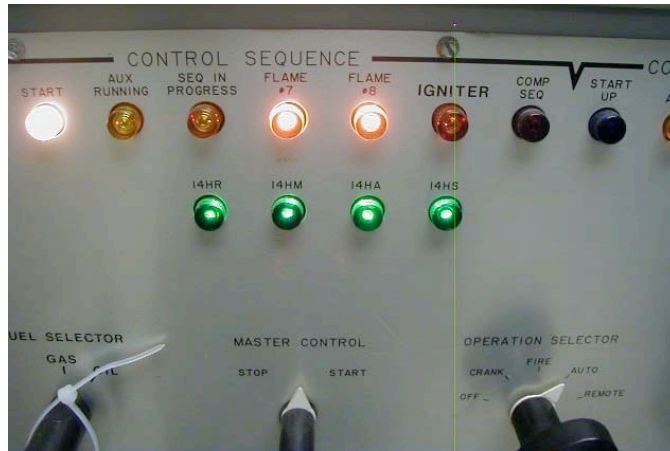
Fig. 2 below shows the turbine up at operating speed (4 green lights are ON for speed relays) but the **Complete Sequence** light is OFF. It is very likely that one of the Motor Control Center (MCC) switches is in the manual position, preventing relay 3-1 from energizing to turn on the RED light indicating that the starting sequence is complete.

Fig. 2: Complete Sequence lights on Mark II Speedtronic Panel

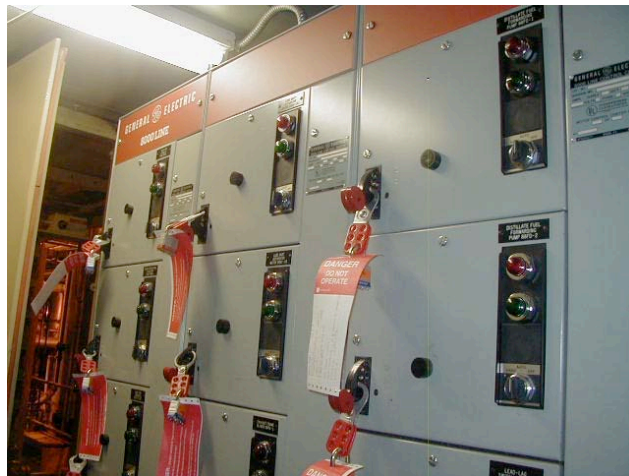
The way that an incomplete sequence condition manifests itself is that the Digital Setpoint (**DSP**) will not allow the generator to be loaded. It will sit at about 3-4 megawatts and not increase in load. The **DSP** counter (flashing sequence of lights on a **LINA** card) will not work. Fig 3 below shows a typical **MCC**. Sometimes a particular motor is tagged out of operation (as shown); other times, the small switch on the lower right of a particular motor is turned to the **MANUAL** position for testing. Before start-up, the switch should be returned to the **AUTO** mode.

Fig. 3: Motor Control Center (MCC) showing switch in the upright **AUTO** mode (lower right side)

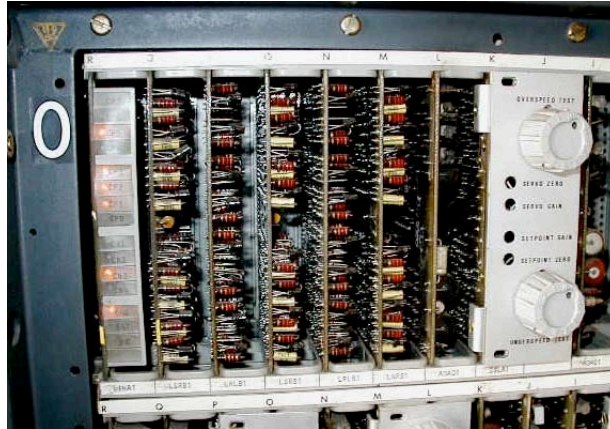
Refer to Fig. 4 below. There are twelve **DSP** lights on the far left for the **LINA** card. The lowest one is **CN4** and the upper one is **CP7**. If the lights do not “count” up or down properly, it could be that a switch in the **MCC** (above in Fig. 3) is not in the **AUTO** mode.

Fig. 4: Binary Counter for Digital Setpoint (12 lights on left from CN4 up to CP7)

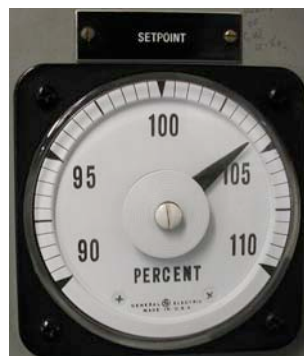
The **DSP** signal is also displayed on a panel analog meter. In Fig. 5 below, the setpoint is at approximately 104.5 %. When the turbine is started, the **DSP** immediately goes to a count of 1809, which is displayed as 100.3%. This is done so as to set the “called-for speed” slightly higher than synchronous speed. When the generator synchronizes to the grid, it will take on approximately 3 percent of rated load. If the generator does not increase load thereafter, the problem might be ***Incomplete Sequence***. Check to see if all the **MCC** switches are in the **AUTO** mode. Also, check to see if relay **3-1** is energized. Test it by pushing the button to see if it allows the **DSP** to function. More on the possible failure of the binary counting system in a future PAL Turbine Tip.

Fig. 5: Digital Setpoint Signal remains at 100.3 %
