JUNE 2004

COOLING AND SEALING AIR

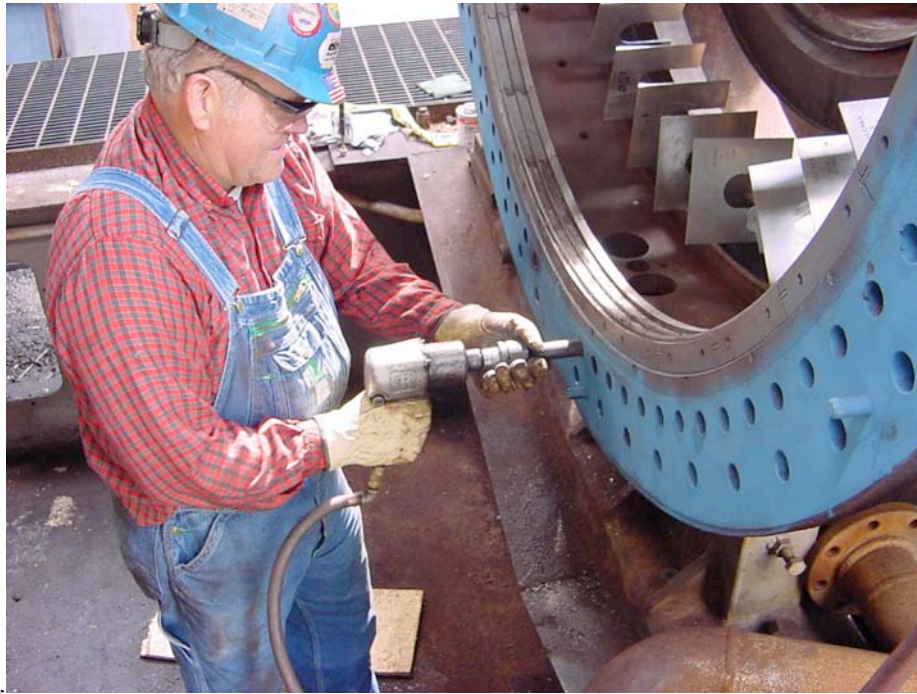
CLEANING THE COOLING AIR PASSAGES

Now for **the most overlooked item during a Frame 5 overhaul**. There are turbine shell cooling holes that pass through the turbine shell into the exhaust frame. The cooling air transmitted through these holes not only cools the turbine shell, it is also used to cool the second stage aft wheel space. Any plugging of these holes increases turbine shell temperature AND limits the amount of cooling air available to the second stage aft wheel space. Remember, the maximum allowable wheel space temperature on an older Frame 5 is 800 degrees Fahrenheit. The problem with cleaning these passages is that removal of the turbine shell and/or the exhaust frame is required to access the holes. No problem for the cooling holes in the upper halves of the turbine shell and exhaust frame, as these casings are normally removed during a major overhaul. The problem is the lower half turbine shell and exhaust frame. Sorry, but to do the job correctly you will have to remove the lower half of the exhaust frame. Failure to clean the lower half cooling holes can cause high differential temperatures between the upper and lower halves of the turbine shell. This can lead to casing warpage, leaking and rubbing of buckets. In addition, a high differential temperature between second stage aft wheel space thermocouples will occur. So remove that lower half exhaust frame, clean the cooling holes, add a tight wire alignment to your work scope and do the job correctly. Purchase new swirl strips as all the old ones will be destroyed during removal.

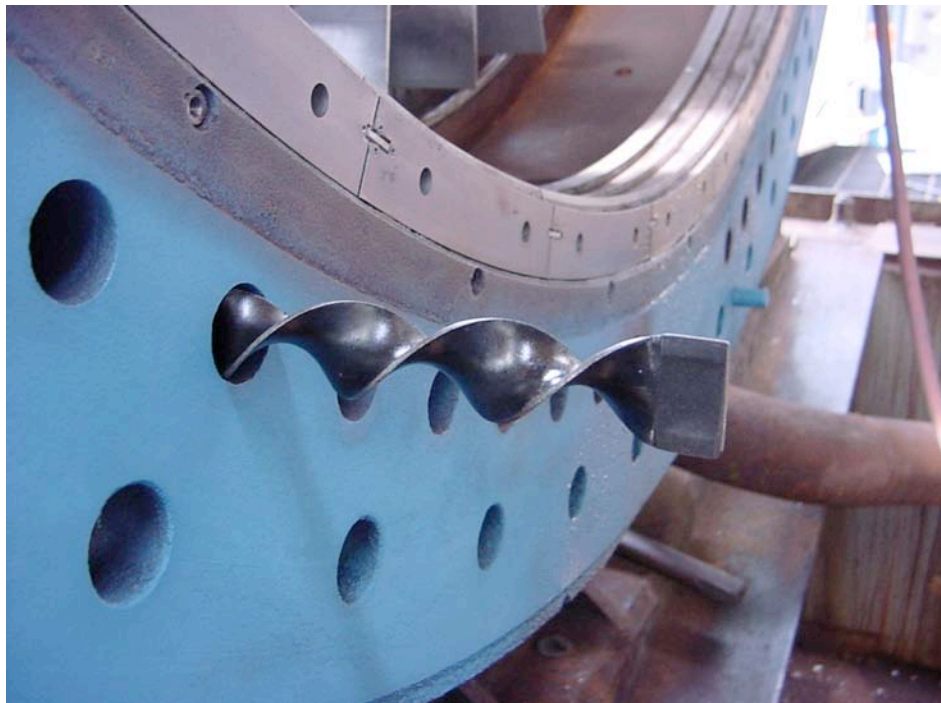
NEW SWIRL STRIP INSERTED HALFWAY IN COOLING PASSAGE

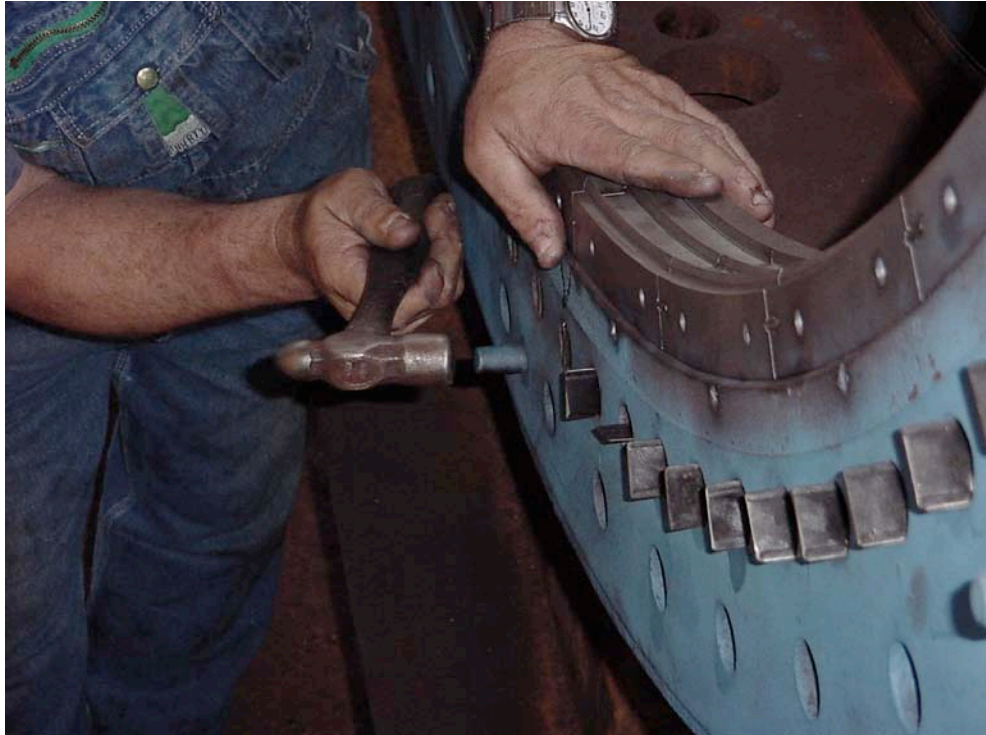
TAPPING NEW SWIRL STRIPS INTO PLACE

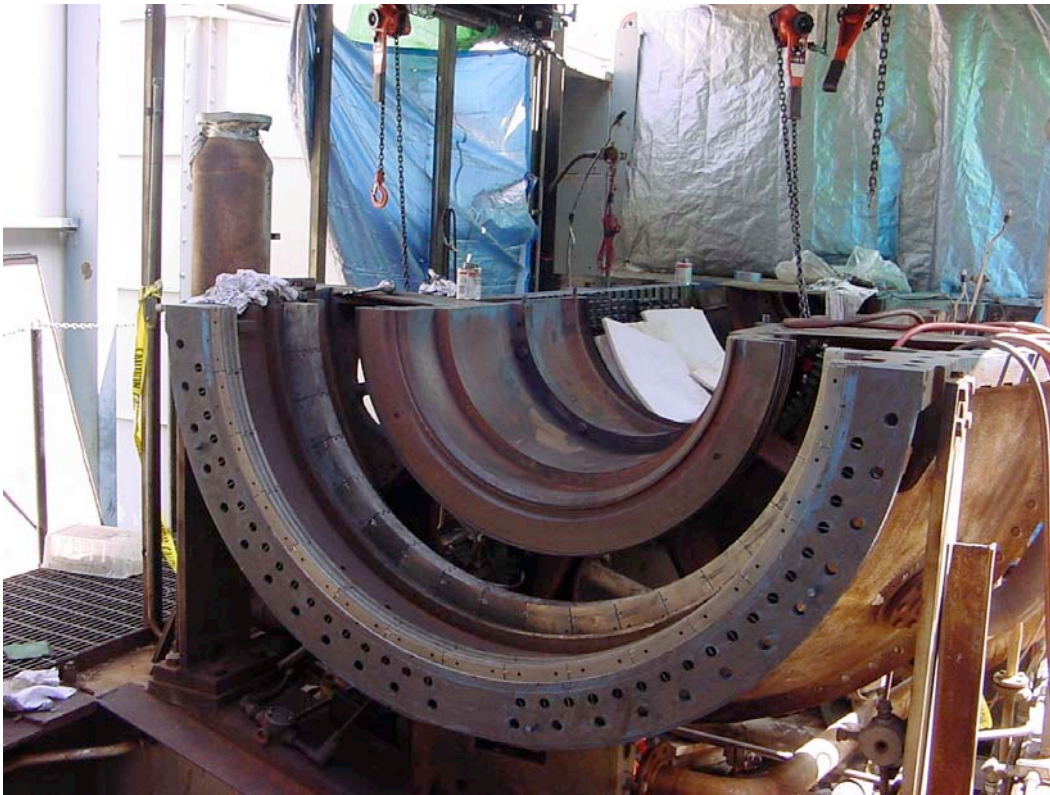
ALL NEW LOWER HALF SWIRL STRIPS INSTALLED
