*January 2006*

**Subject: Lube Oil Leaks in Accessory Gear**

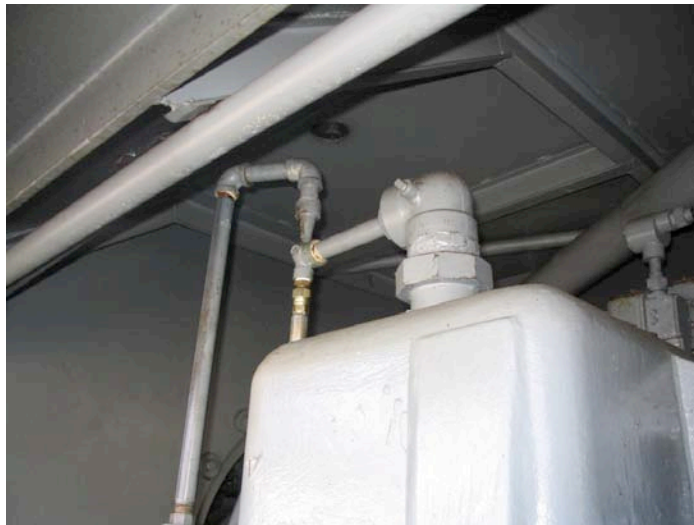
On most GE gas turbines, the accessory gear is vented using a *venturi* located on top of the gear box. If this simple device does not work properly, the gear box will pressurize and allow oil to leak out of bearing seals into the accessory compartment, presenting a fire hazard. See Fig. 1 below for the vent.

Fig. 1: Venturi atop gear box

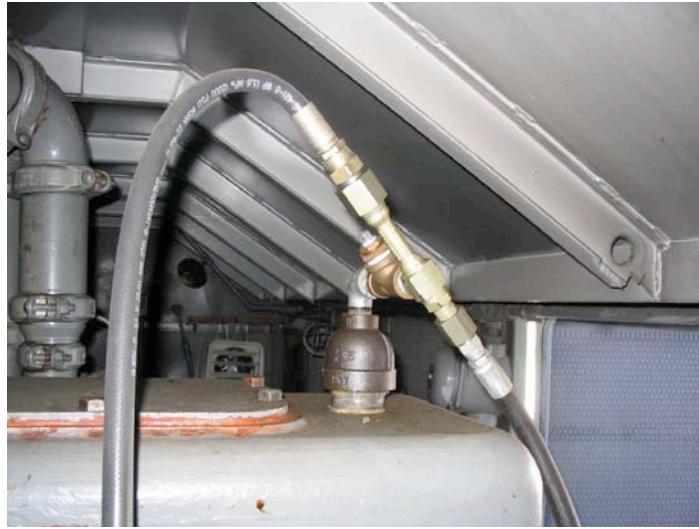
The *venturi* requires a low-pressure source of air from the turbine's axial-flow compressor to work properly. See flex hosing leading to and from the venturi in the rear as shown in Fig. 2 below.

Fig. 2: Air lines going to and from venturi

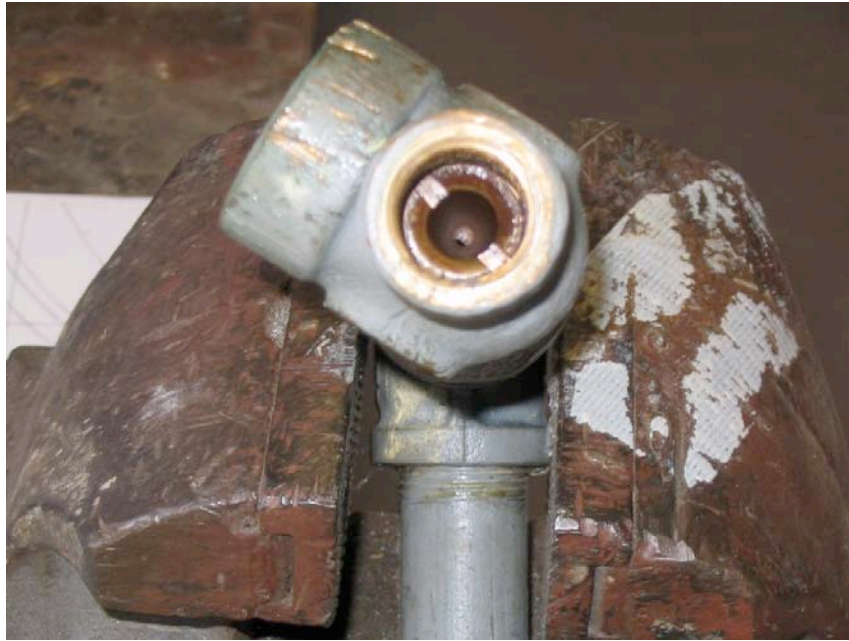
Also, it is important to occasionally check the *venturi* passageway itself, which must be clean of debris. Once the cover on top of the *venturi* is removed, determine if it is “clogged.” The passageway is blocked in Fig. 3 below.

Fig. 3: Cover removed on venturi, opening clogged

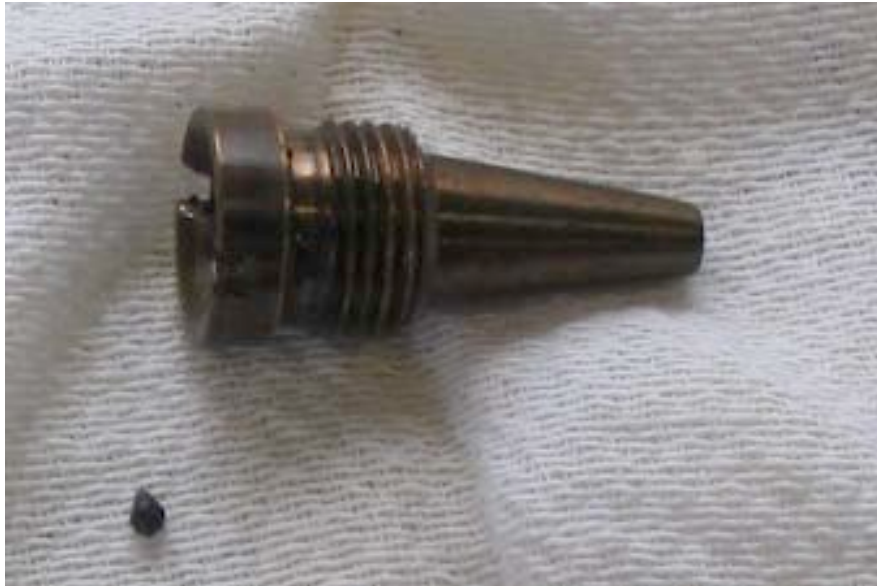
The *venturi* can be unscrewed and removed as shown in Fig. 4 below. The tapered shape of the venturi is apparent in the photo. Also, the foreign material “clogging” the opening of the venturi is obvious.

Fig. 4: Venturi unscrewed and removed atop gear box. Debris or clog is also shown

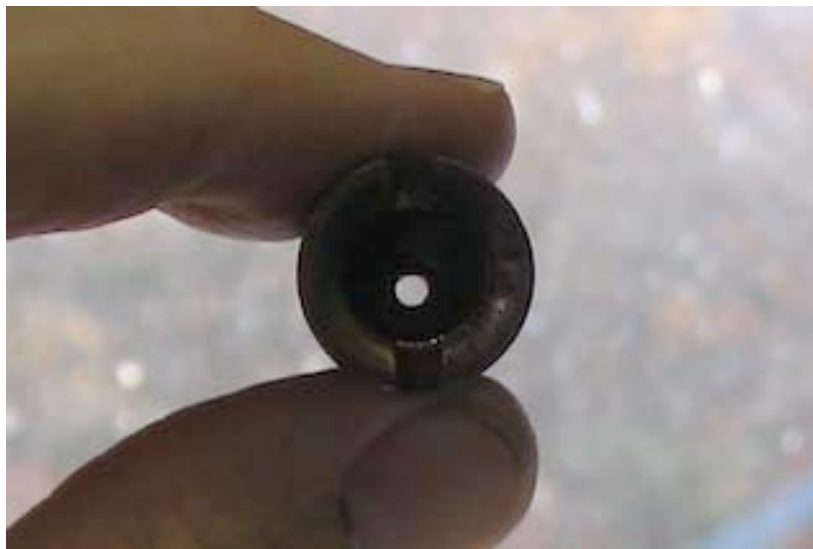
Fig. 5: Clean venturi opening

Fig. 5 below shows a clean *venturi* opening ready for reassembly. It can be screwed back into the retainer atop the accessory gear.

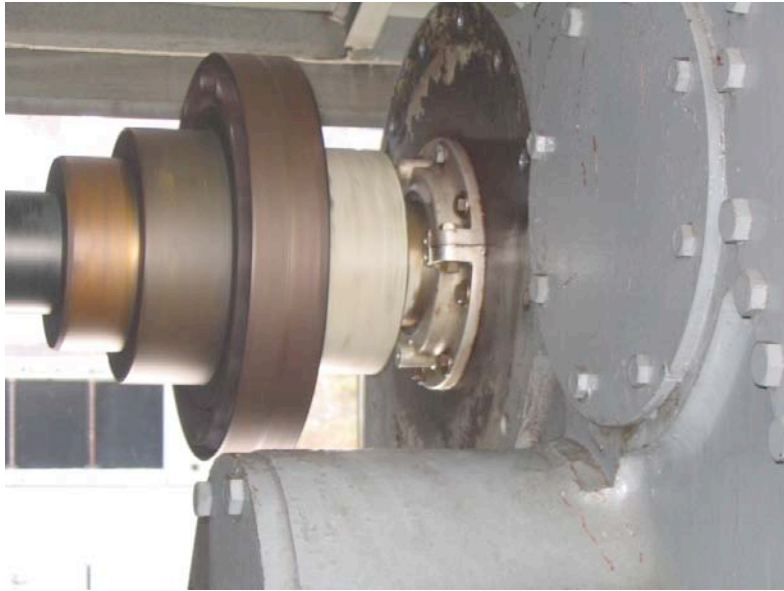
Fig. 6: Accessory Coupling and bearing operating without leaks

After reassembling the *venturi*, the turbine should be started with the accessory coupling cover removed, as shown in Fig. 6, to assure that oil is no longer dripping out of the bearing seal in the gear box. In the photo below, no oil is apparently leaking from the bearing (on the right) of the accessory gear box.
