How to change Inlet Guide Vanes . . .

. . . WITH THE ROTOR IN PLACE

CHARLES POND AND
DAVID LUCIER

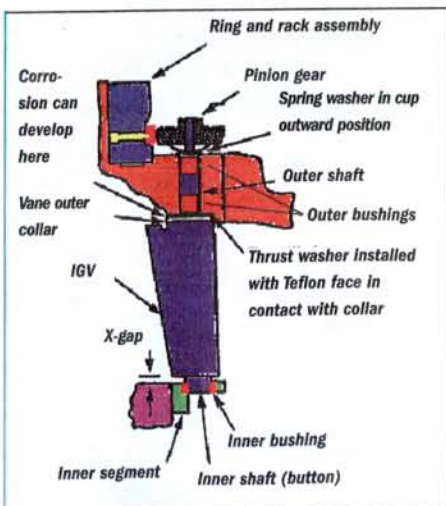
Figure 1: IGV construction sketch

On GE models 5000, 6000 and 7000, it is now possible to change the variable Inlet Guide Vanes (IGV) with the rotor in place. The variable IGVs (Figure 1) serve two purposes: They prevent compressor stalls during startup, and modulate airflow to maximize exhaust temperature on units with waste heat boilers.

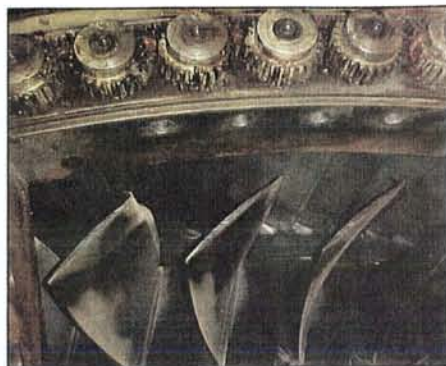
There are 64 IGVs mounted on the inlet bell-mouth. Each vane has a pinion gear on the end rotated by a rack gear (Figure 2). The rack gear is mounted on a control ring which is actuated by a large hydraulic actuator. In a few rare cases, a limit-torque motor is used instead of a hydraulic actuator.

Clockwise from top
Figure 2: IGVs, 1st stage blades and pinion gears engaging with rack

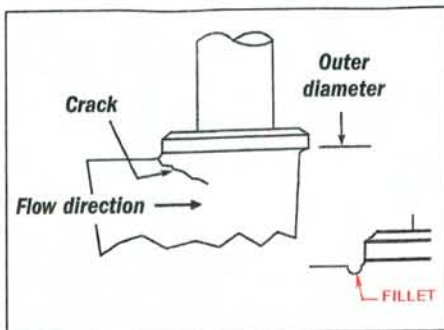
Older IGVs were susceptible to cracking where the airfoil met the shaft. This was a serious concern (TILs 511, 515, 522, 532). The crack can lead to a catastrophic IGV failure. Failures occurred at about 25,000-30,000 hours of operation. Crack inspection needs to be performed at 4,000-hour intervals. New-style IGVs incorporate a small fillet (Figure 6)

Clockwise from top
Figure 6: New-style IGVs have a small fillet that prevents crack formation
Figure 7: Parts in IGV assembly
Figure 8: Inlet bellmouth and IGVs
Figure 9: Jacking bolt modification added to bellmouth
Figure 10: IGVs and support blocks
Figure 11: Support block bolted to inlet bellmouth
Figure 12: Removing the lower half IGVs is difficult because the working space is only 2 inches
Figure 13: Protractor used to set vane angle

to prevent crack formation.

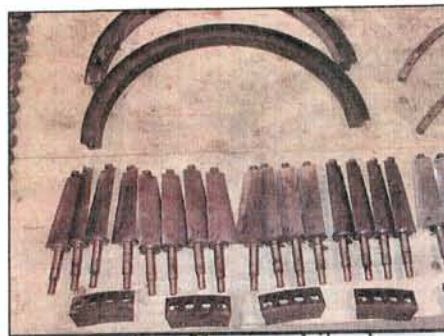
Changing the IGVs is a difficult and repetitive task. The parts are numerous. There are 64 IGVs, 192 bushings, 192 washers, 64 pinion gears, 64 locking pins, 64 set screws, 16 support blocks, 4 rack gears, 2 pinion covers and 4 pointer parts. A total of 666 parts (Figure 7). No wonder it is a devil of a job.

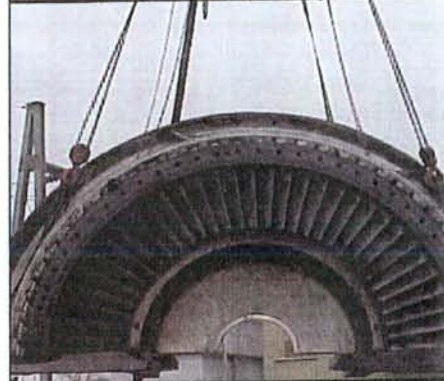
To change the IGVs, you must first remove the inlet elbow, upper-half inlet plenum and the upper-half inlet bellmouth (Figure 8). The inlet bellmouth does not have jacking bolts. Therefore you will need to use wedges to split the horizontal joint. This is a good time to add jacking bolt holes (Figure 9).
