Legacy Roundtable does rotors

In Annapolis, the subject of the session was rotors. PSEG Power's Rich Rebori, chairman of the Aero Roundtable, presented on the overhaul of rotors on two 7EAs. He made suggestions on what to look for when inspecting rotors so that others might avoid some of the problems his units experienced. Rebori talked

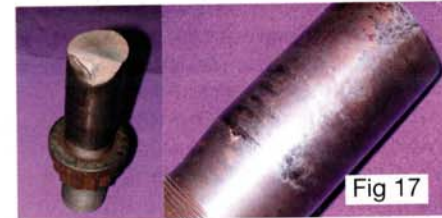
Fig 17

Another cause of vibration—one characterized by a sudden increase in vibration level—is the failure of a through-bolt (Fig 17). Failure of the through-bolt in single-bolt rotor designs is conducive to rotor destruction. A mod to prevent through-bolt failures on older GE units is described in TIL-1257-3. This is an important reference for any manager responsible for the first-time destacking of an older rotor. An NDE technique for inspecting through-bolts in service was presented by Pond.

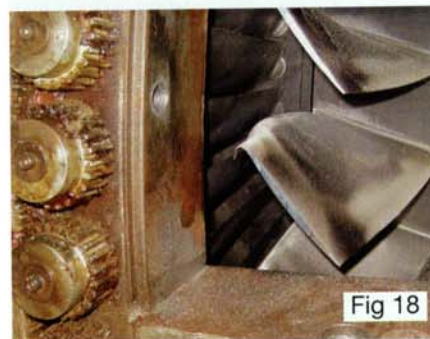
Fig 18

If you find blade damage when inspecting your compressors, Figs 18-20 may help identify the source. Ice caused the damage in Fig 18, debris (foreign object damage) in Fig 19, and erosion from over-spray during inlet fogging in Fig 20. CCJ
