# How to change Inlet Guide Vanes . . .

. . . WITH THE ROTOR IN PLACE

CHARLES POND AND  
DAVID LUCIER

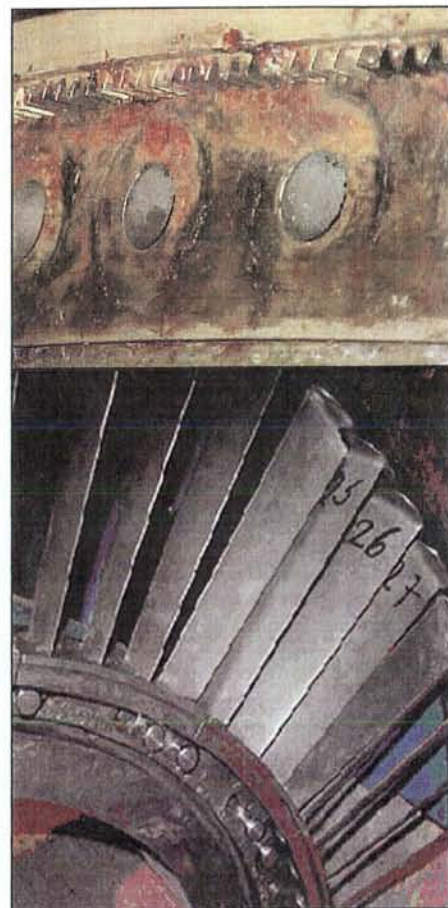
Figure 4: Closed IGVs block air flow

Figure 5: C-450 IGVs can be made thinner, allowing more air flow and increasing power output

ward as they bite into the air. When a blade encounters a closed IGV, it relaxes for an instant because the incoming air is blocked (Figure 4). The high cycle fatigue (60 hz) will lead to a rotor blade failure at the blade root. Once the blade liberates, it causes catastrophic damage downstream.

The old-style IGVs were made of 403 or 316 Stainless Steel. The new-style ones are made of C-450. C-450 is a much stronger material and consequently can be made thinner, which in turn allows more airflow into the compressor (Figure 5). You will gain a 2% increase in flow. This translates to 2% more power output and is therefore an excellent upgrade for the money.
